Manhole Inspection Summary

Manhole # S31K1_007MH

Insp Date: **3/20/08 11:16 AM**

Location Address: **2557 Seamon Avenue**

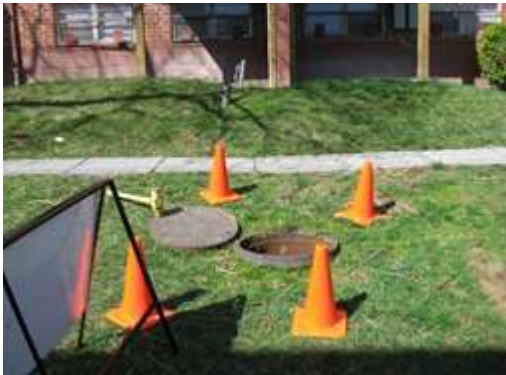
Location View

2581 Seamon Ave.

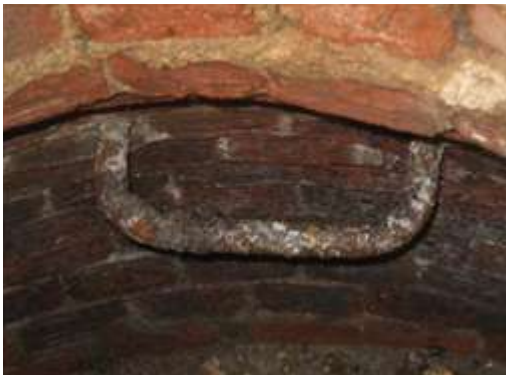
Step

Count: **1** Missing: **0** ☐ Corroded

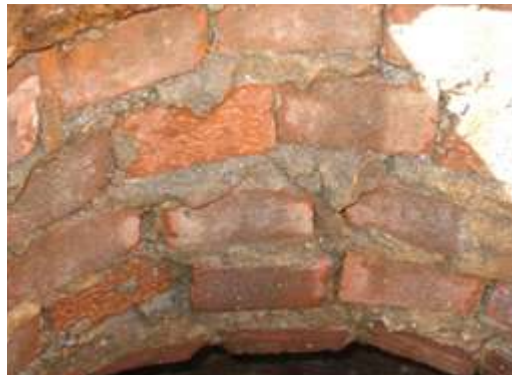
Defect 2

Infiltration: ☐ None ☐ Joint ☐ Cracks ☒ Mortar ☐ Roots ☐ Wall

Infiltration

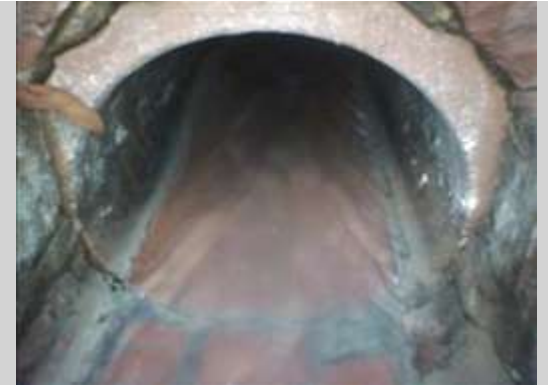
12 O'Clock Outflow

8 in. Circular Gravity Sewer
Pipe Out @ 12 O'Clock

Pipe Height: **9.6** (in.) Rod and Bar (Angled)
Pipe Material: **Clay** ☐ Pipe Lined
Invert Depth: **5.76** (ft.) Flow Characteristics: **Fast**
Deposits: ☒ None ☐ Mud ☐ Sludge ☐ Debris ☐ Grease
Silt Depth: (in.) Deposits Extent:
Infiltration: **None** Pipe Seal Cond: **Sound**

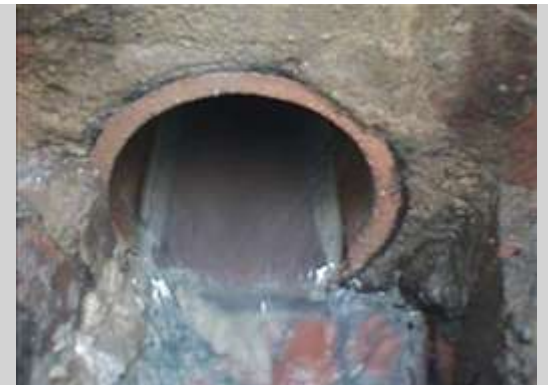
3 O'Clock Inflow

8 in. Circular Gravity Sewer
Pipe In @ 3 O'Clock

Pipe Height: **8.4** (in.) Rod and Bar (Angled)
Pipe Material: **Clay** ☐ Pipe Lined
Invert Depth: **5.40** (ft.) Flow Characteristics: **Fast**
Deposits: ☒ None ☐ Mud ☐ Sludge ☐ Debris ☐ Grease
Silt Depth: (in.) Deposits Extent:
Infiltration: **None** Pipe Seal Cond: **Sound**

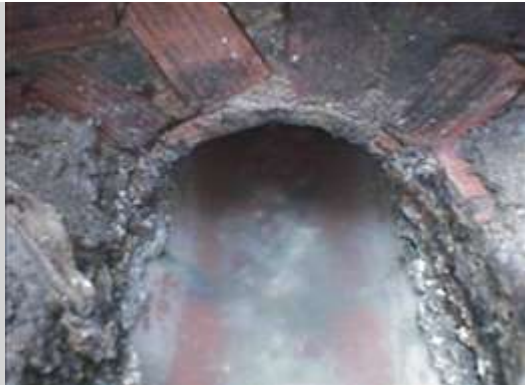
6 O'Clock Inflow

6 in. Circular Service Sewer
Pipe In @ 6 O'Clock

Infiltration: **None**

Pipe Seal Cond: **Sound**

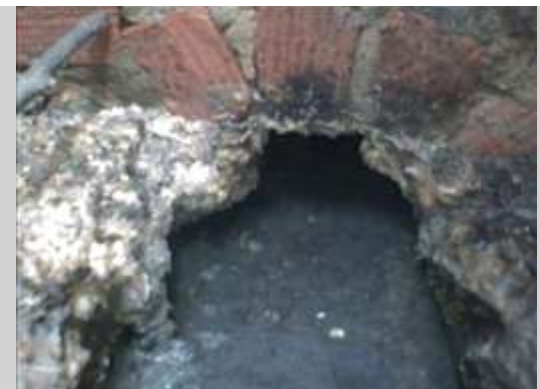
9 O'Clock Inflow

8 in. Circular Gravity Sewer
Pipe In @ 9 O'Clock

Invert Depth: **5.65** (ft.) Flow Characteristics: **Slow**

Pipe Seal Cond: **Unknown**
